Incidents and Near misses

Aker BP & Equinor – 2023-2024

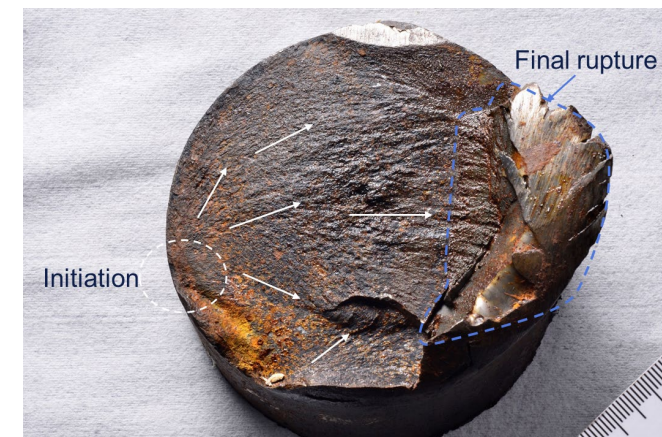
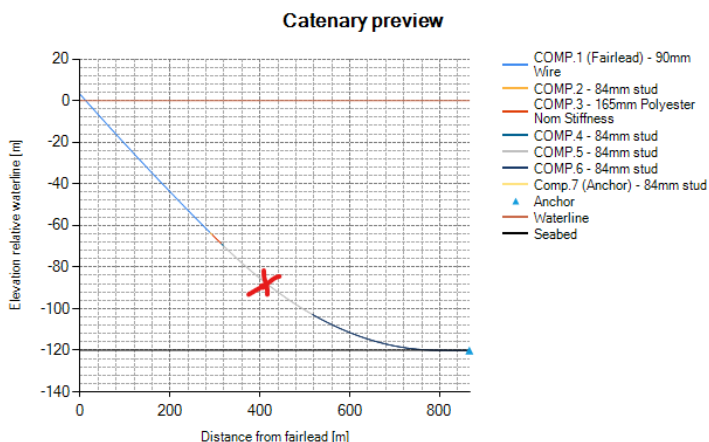
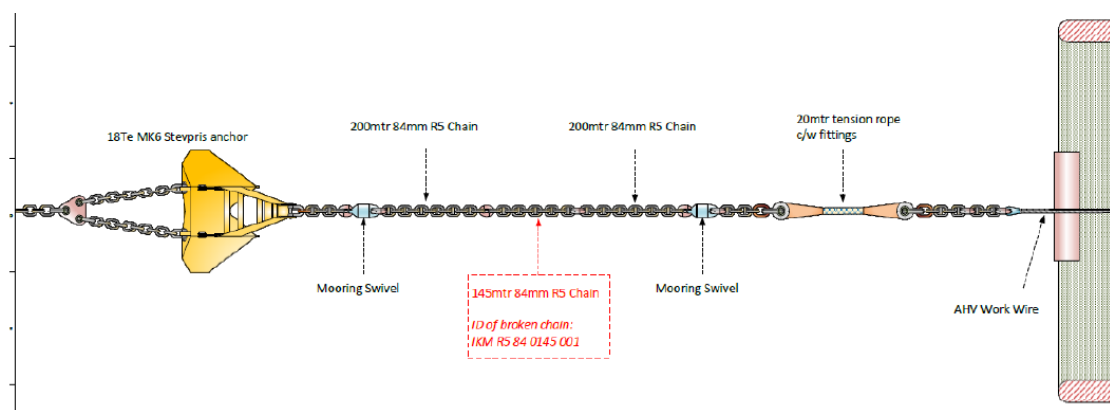
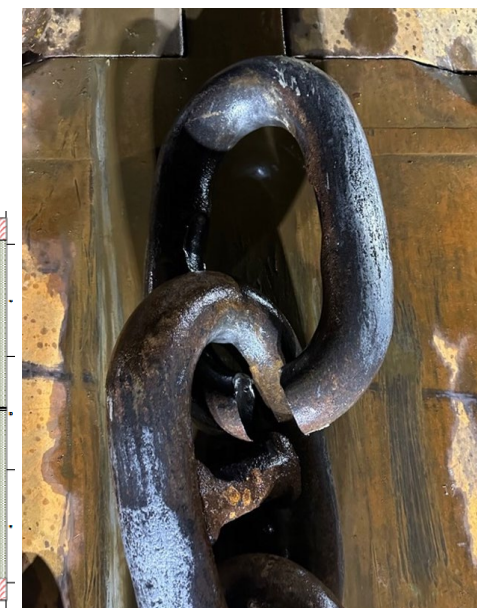
Chain Breakage during pre lay – SC8 @ FGD

- During pre lay at FGD an 84mm R5 chain segment broke. Breakage happened in the crown. Chain was from Ramnæs Bruk AB.
- 2,5m Hs and 320Te tension. Water depth 120m. Polyester used between wire and chain. ICCP turned off.

- Link 491 broke. Links 481 to 490 and 490 to 501, in addition to 491 was examined. In addition, several segments of the chain was sent to DNV for high mean load test (40-50% MBL 400Te). JIP.

- Investigation shows tensile strength and hardness within DNV-OS-302 (356 HV and 1113 Mpa).
- Material has failed in a brittle manner, characterized by intergranular cracking. Not possible to establish if a pre-existing crack had been present before the main fracture has started to propagate. Final rupture is a dimpled ductile rupture (overload).

- Based on previous examination of this type of material, the findings support hydrogen induced cracking to be the reason for the failure of the link.

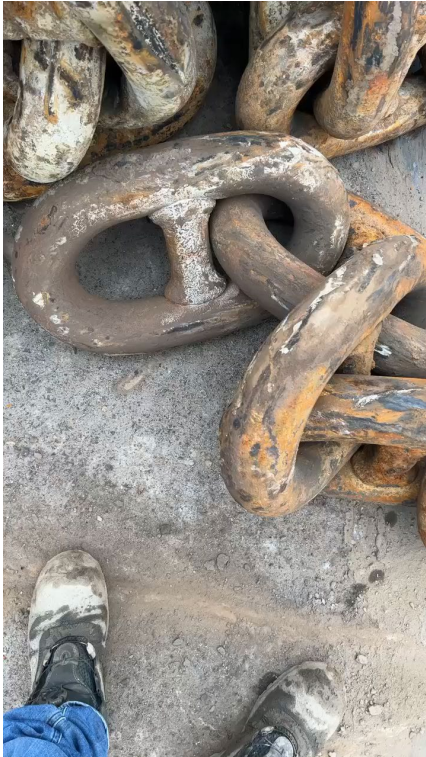
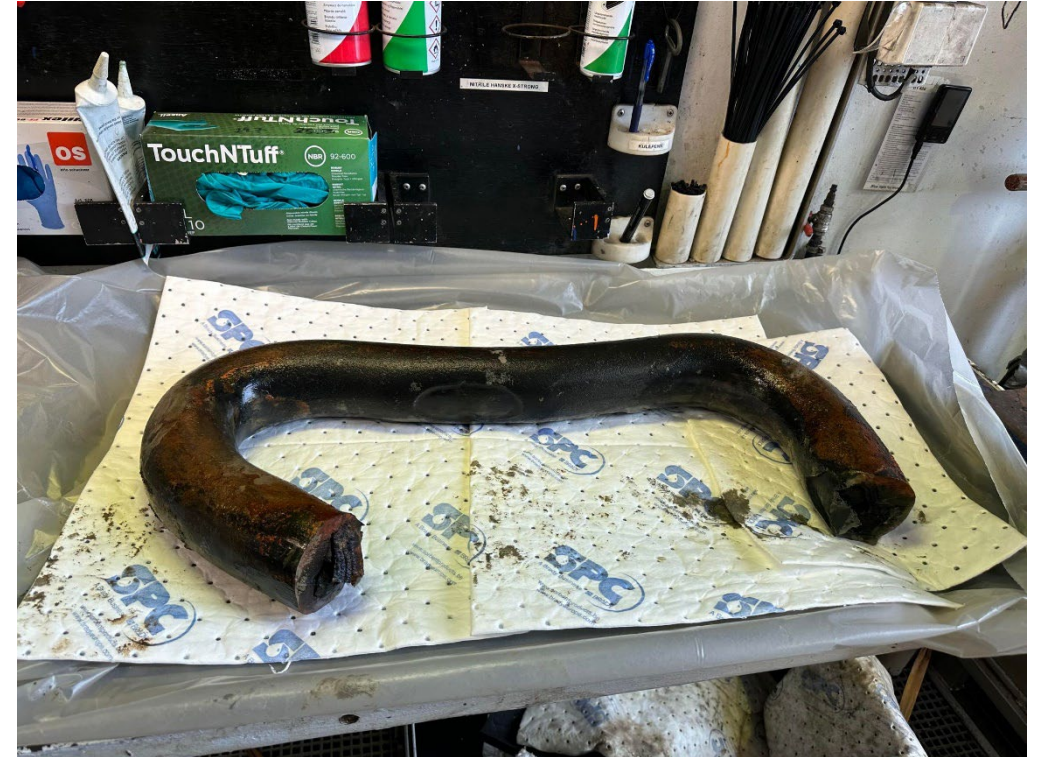
Damaged link – recovered and sent to Høvik

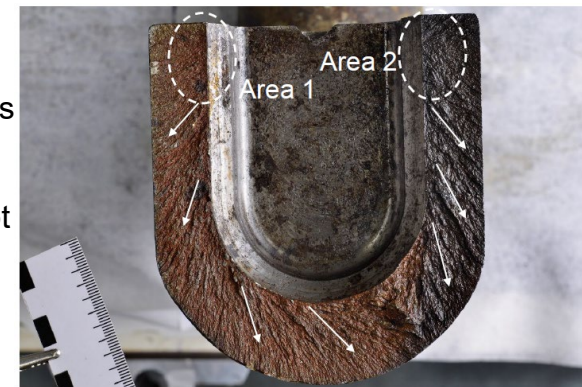
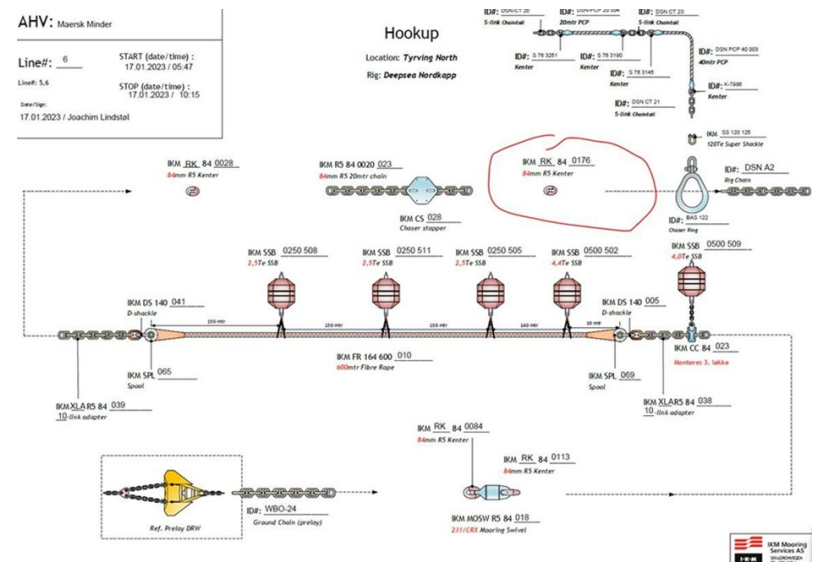
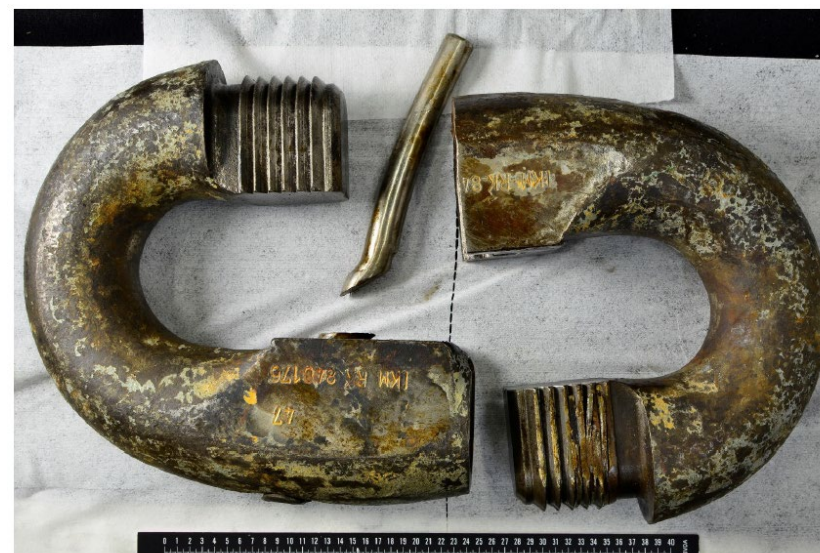
Kenter Link Breakage – DSN @ Trell

- During operation at Trell a 84mm R5 kenter type Feuerstein Raptor broke. From 2014 and re certified in 2020. Usage: 360 days
- 220Te tension in the mooring line. Position is shown in drawing. Rig movement after failure as expected.
- Good preservation was done, and the link was sent to DNV for investigation. Fracture initiated in two locations. Both fatigue hot spots for kenter links. Initial fracture is fatigue fracture mode (0,5mm depth) → Propagated in a brittle manner
- Hardness testing (HV) shows very high values (397 HV10 and 1250Mpa). DNV-OS-302 (356 HV and 1113 Mpa).
- Charpy testing at -20 deg shows values below req. Average 17 J. DNV-OS-302 (44 J)
- Certificate states that all values should be within DNV req.
- Microstructure examination shows that material have been tempered.

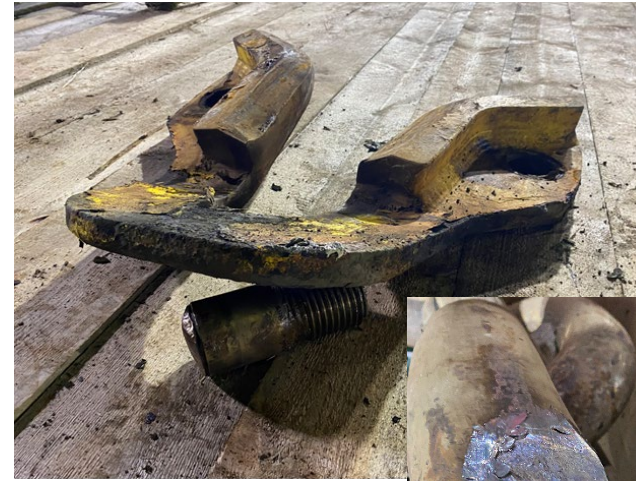
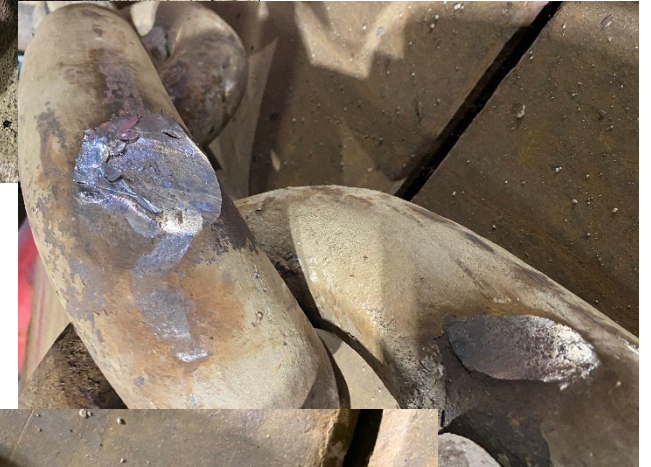
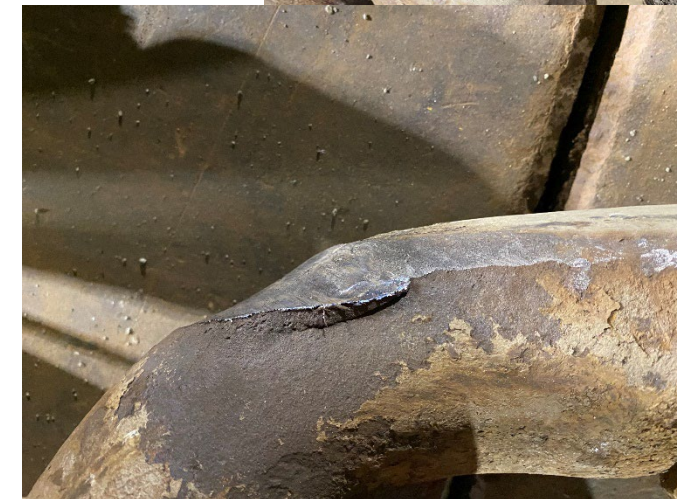
Damage to 84mm R5 chain and shark yaw insert

- During mobilization the chain was secured in the vessels shark yaw
- Winch operator got distracted by personnel on the bridge. 2nd officer was occupied with paperwork.
- Lead to the chain getting tightened up in the shark yaw.
- Consequence: Damaged insert and chain.
- This is a low-tension operation, but winch operator registered a spike of 350t on the winch monitoring system.
- Large potential.

Focus needs to in place in every step of the operation

Be aware – even during «simple» or «routine» operations

All involved should keep track of operation sequences.

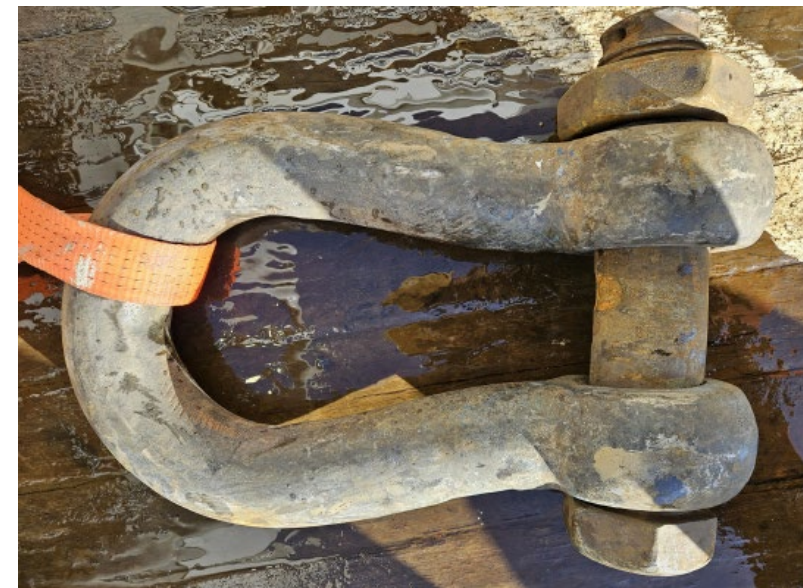
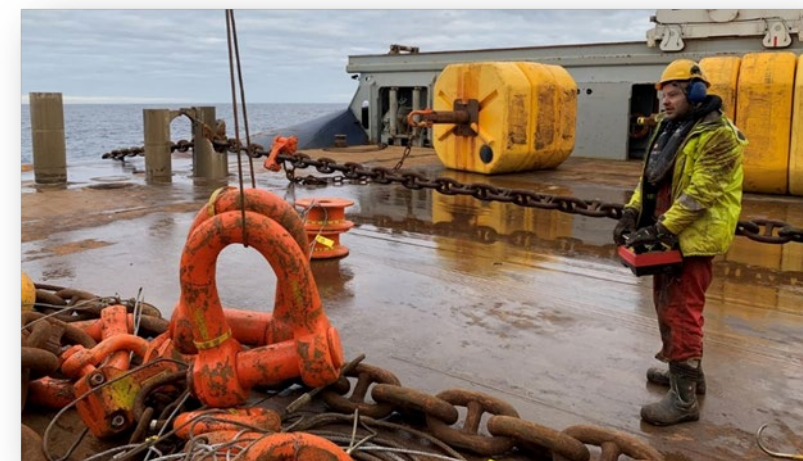
120t shackle used instead of kenterlink

- During recovery operation, a 120t shackle was used between vessels work wire and bottom chain.
- Neither deck crew, ID-rep, bridge crew or marine reps caught this wrongdoing during connection.
- Damaged shackle
- Large potential

Focus needs to in place in every step of the operation

Be aware – even during «simple» or «routine» operations

All involved should keep track of operation sequences

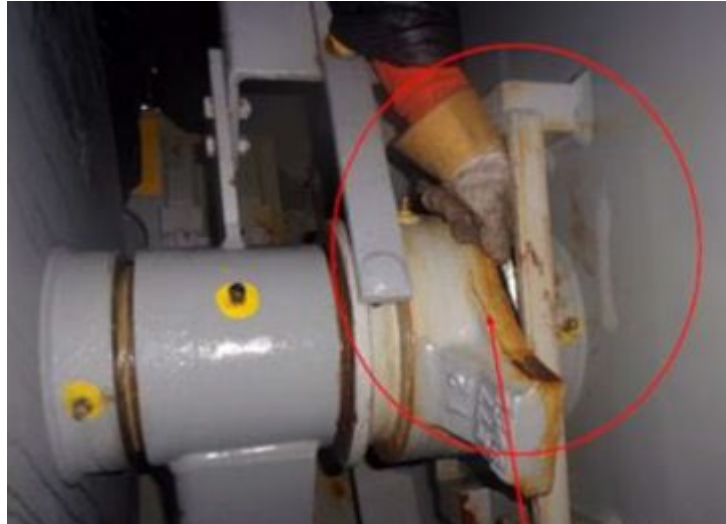
Routine greasing of mooring winch

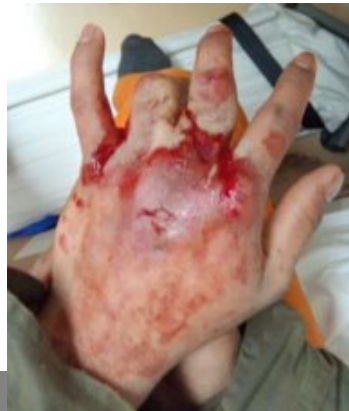
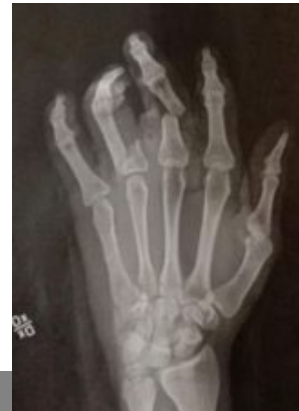
Position of hand during injury.
Removing old grease using short length hacksaw blade

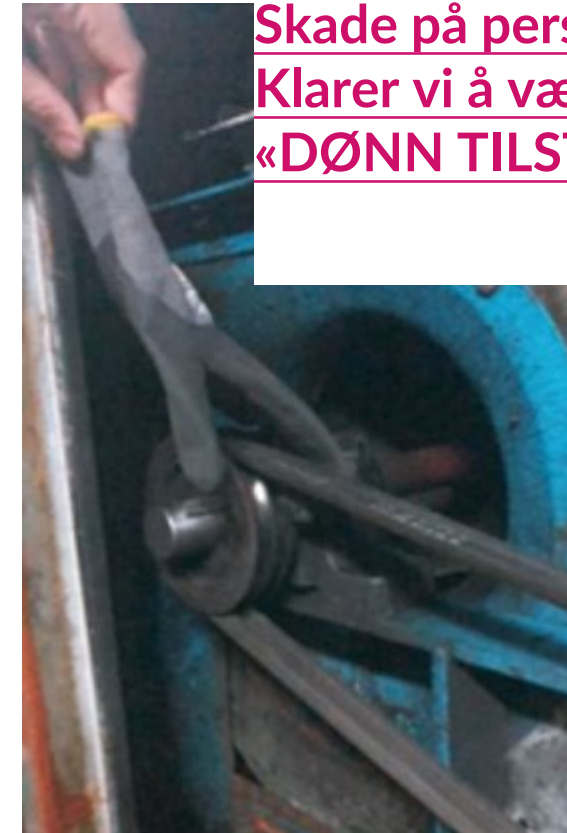
Partial amputation

glove pulled into AC

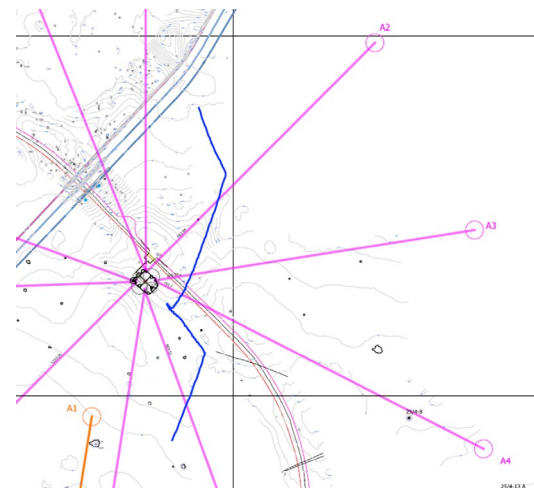
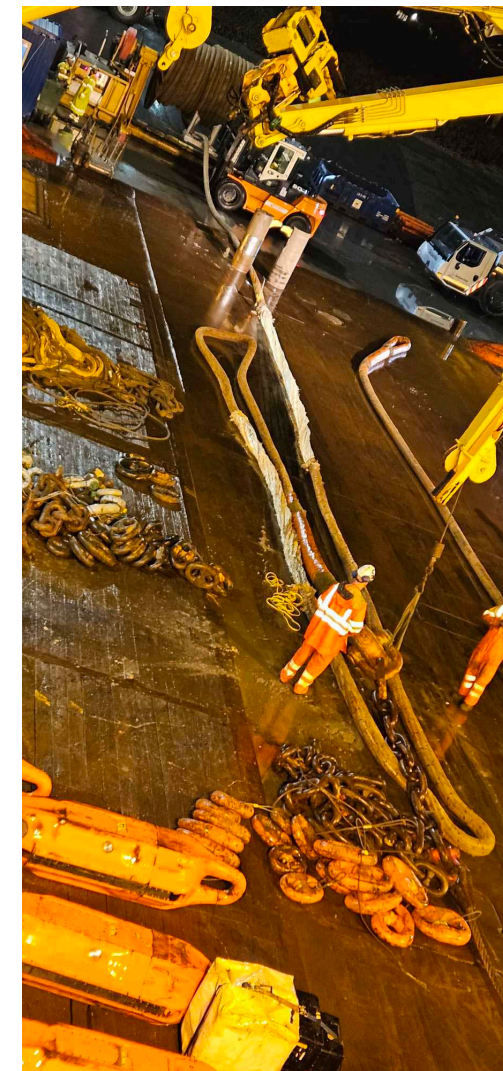
Fiber rope damage

- Fiber rope protection missing – discovered during recovery. On mooring line #3
- No one admits to have done something wrong
- But investigation shows that a vessel has crossed the polyester during its time in the sea.
- Could easily have led to a line breakage.

Focus on in-field traffic and movement

Always report incidents to AkerBP as soon as possible

Increased information to parties on mooring spreads

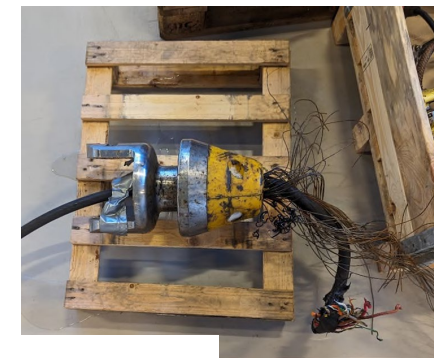
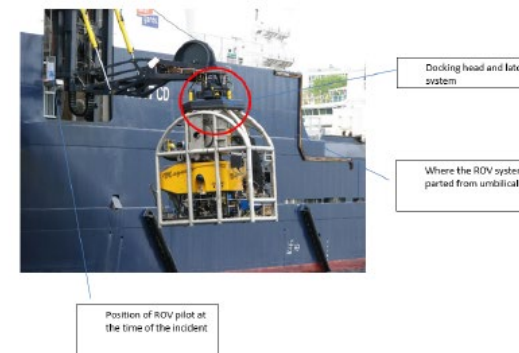
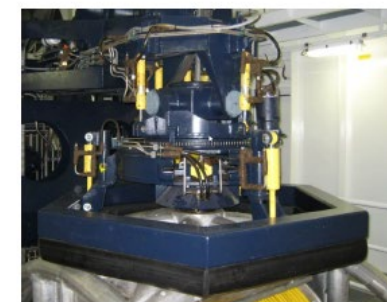
Loss of ROV

- During recovery of an ROV January 2024 the TMS umbilical broke. Weather was ok.
- Investigation shows that the umbilical was cut by the latching system. Instead of locking the ROV in position the system cut the umbilical.
- Four main factors leading to the incident to occur.
 - Procedures for operation not followed. Operator did not see the indication flag for the latching system.
 - Not enough mechanical barriers to prevent the possibility of cutting the umbilical.

Close up picture of latch system when it was new in 2007.

Procedures is to be followed.

Stop the job is important.

System to be improved.
