Mooring Challenges 2023

R5 chain challenges

Titan mooring line – and breakage

Elizabeth Hostrup – MOP 17-18 April 2024

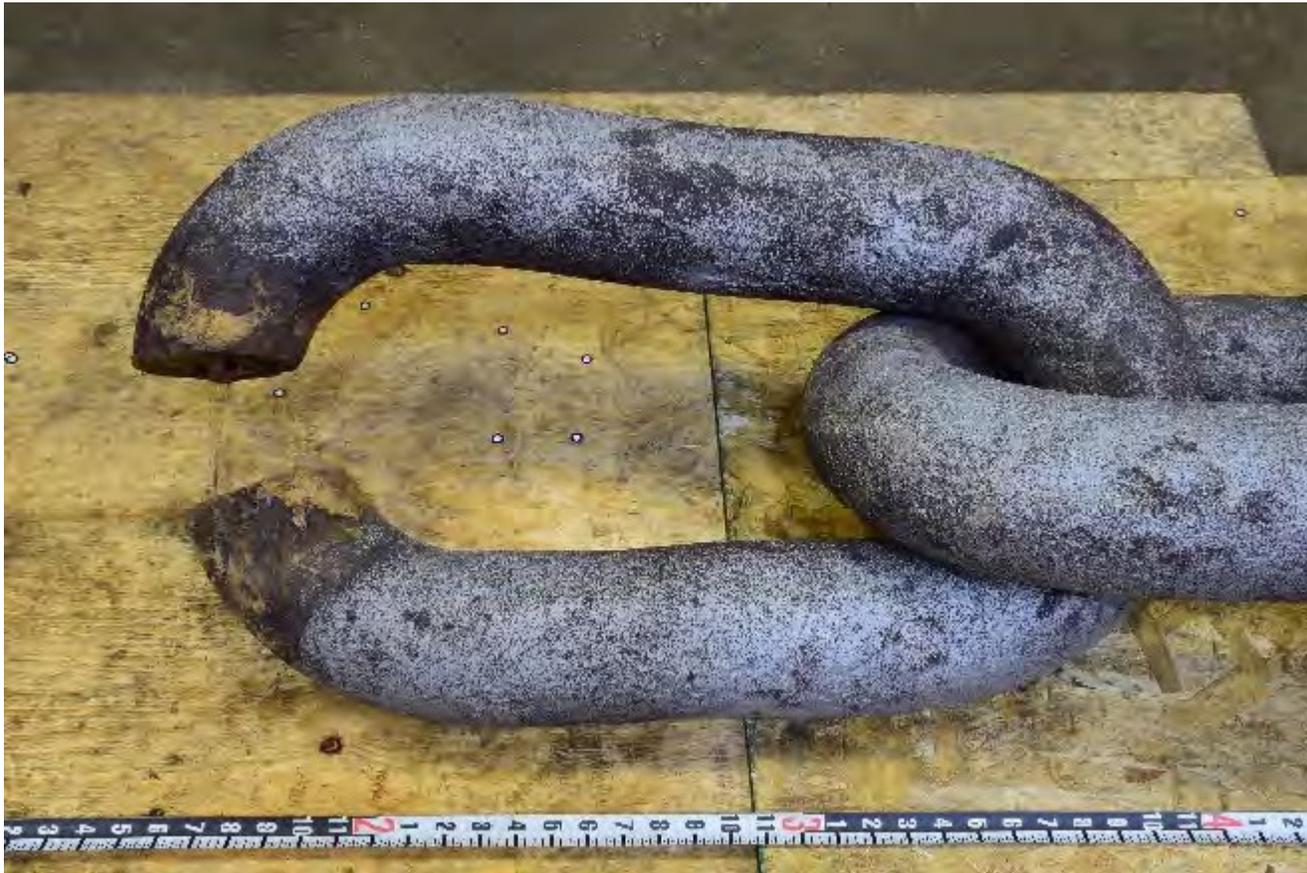
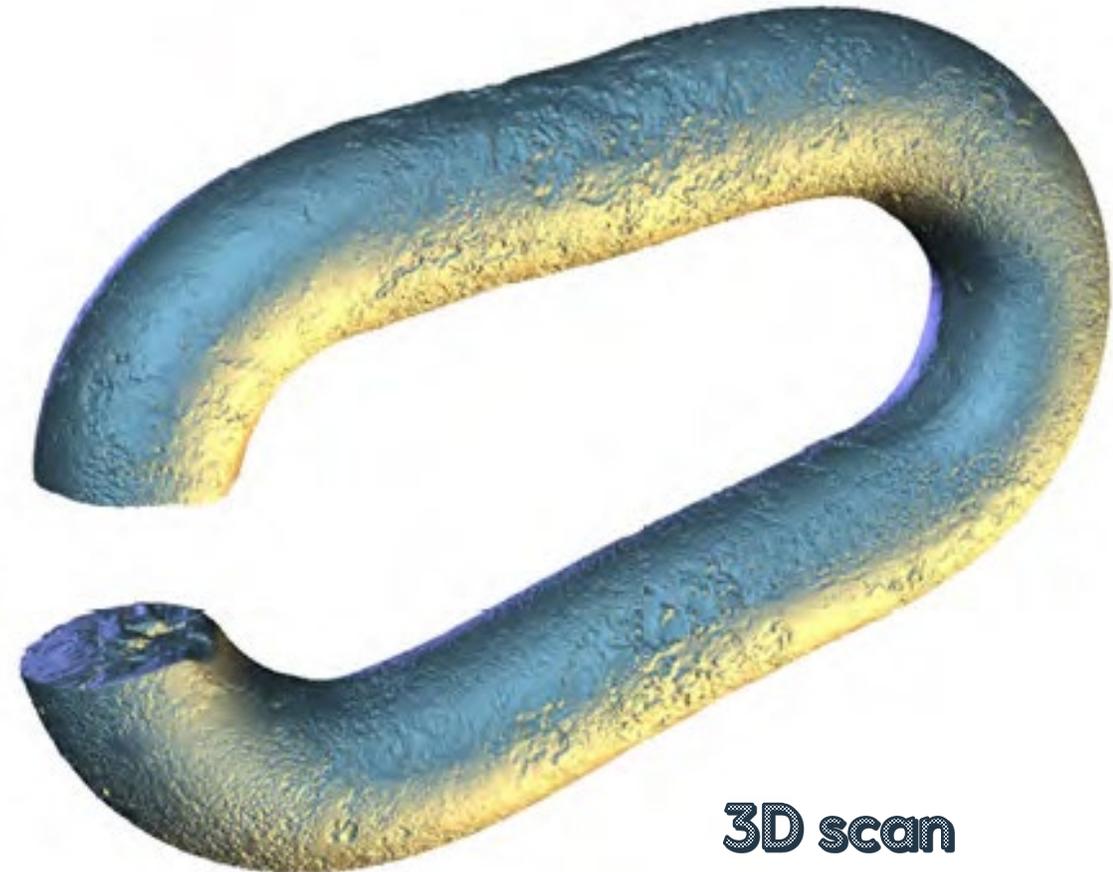
The broken link

- Crown breakage. Typical for fatigue and hydrogen assisted cracking

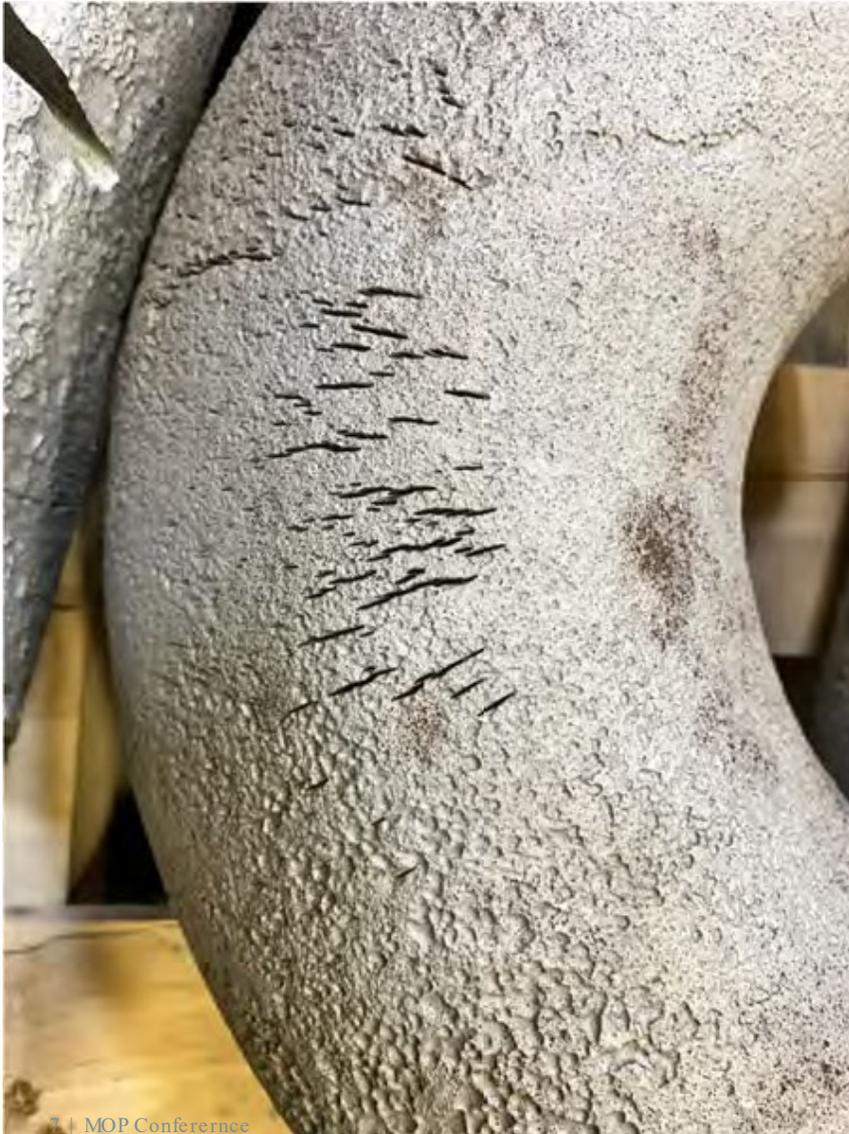
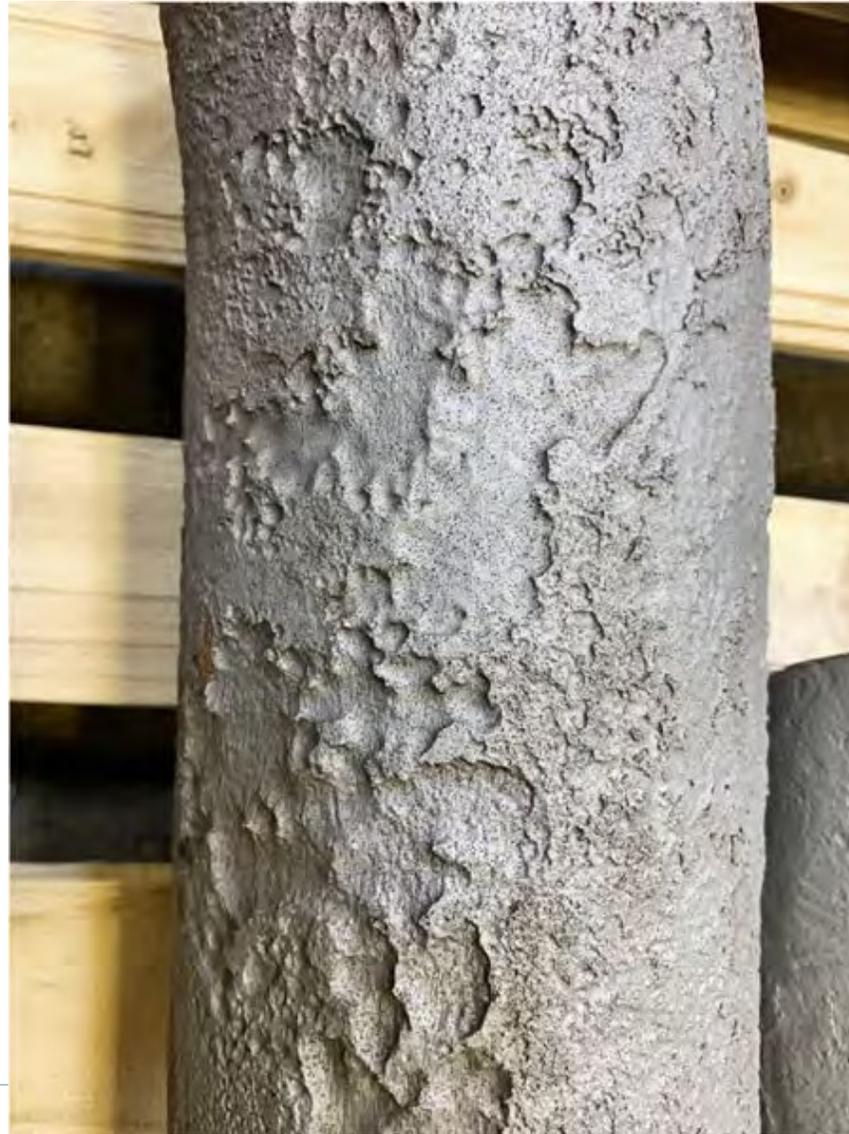
Chain surface condition (all 7 links)

- Crack-like surface grooves on crown sides. Also on top of crown on some links.
- Pittings with pattern known from bacterial corrosion (Sulphate Reducing Bacteria - SRB)

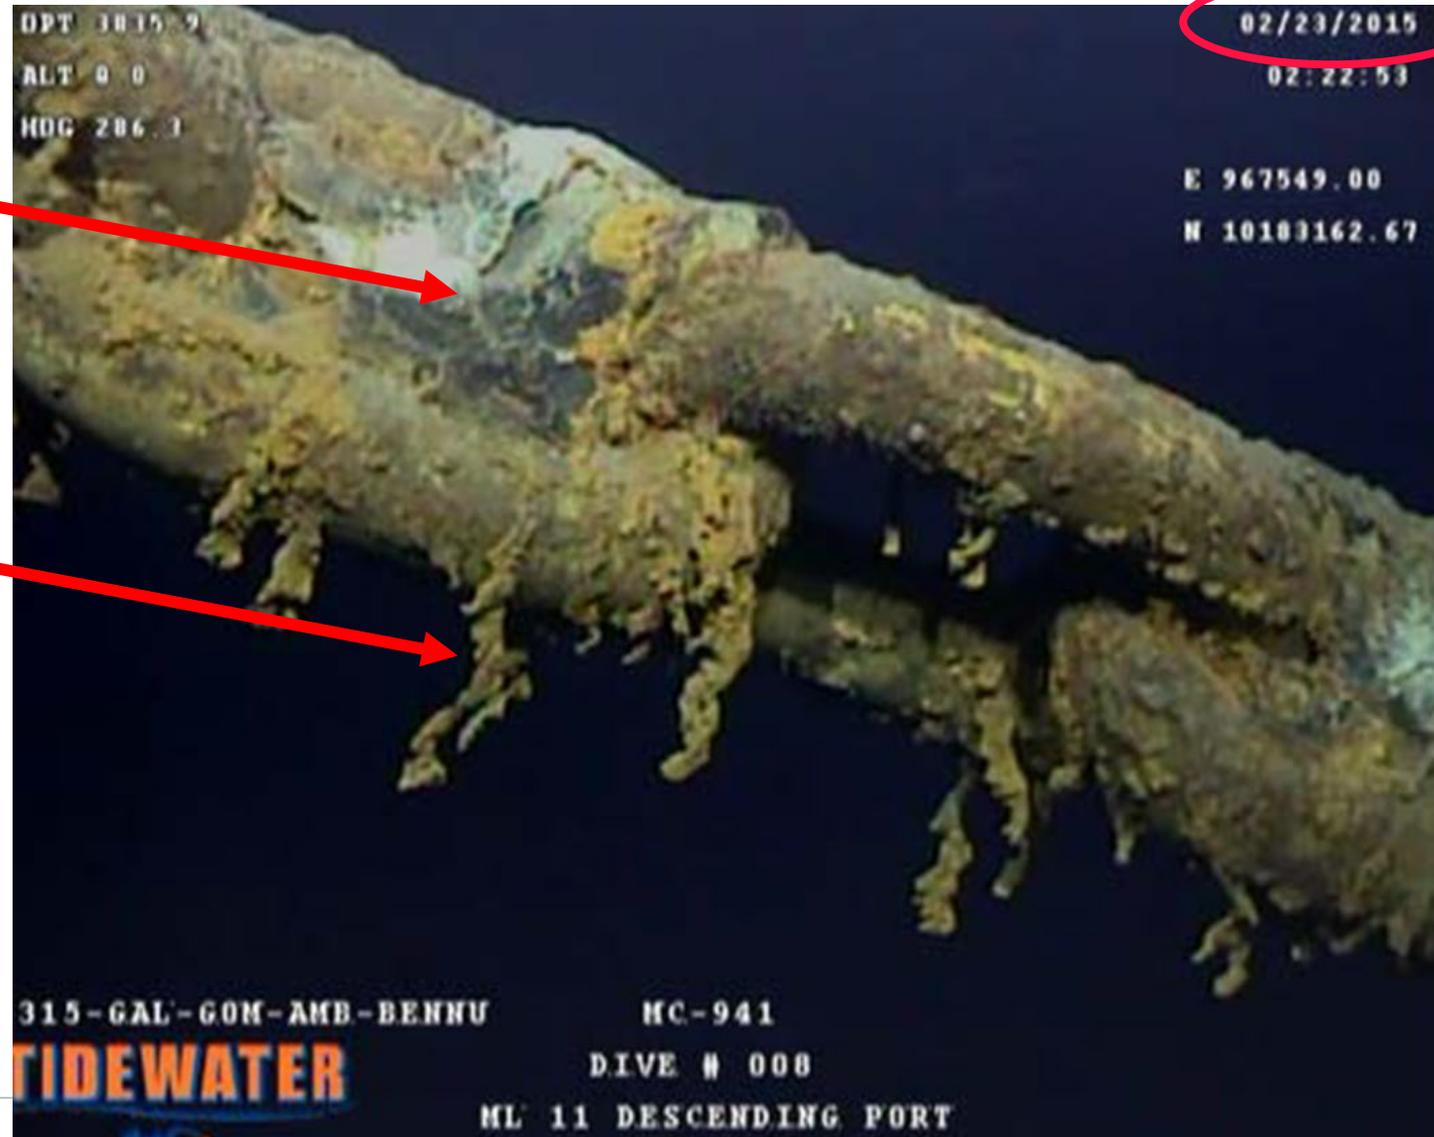
General inspection findings

Grey stuff

Rusticles

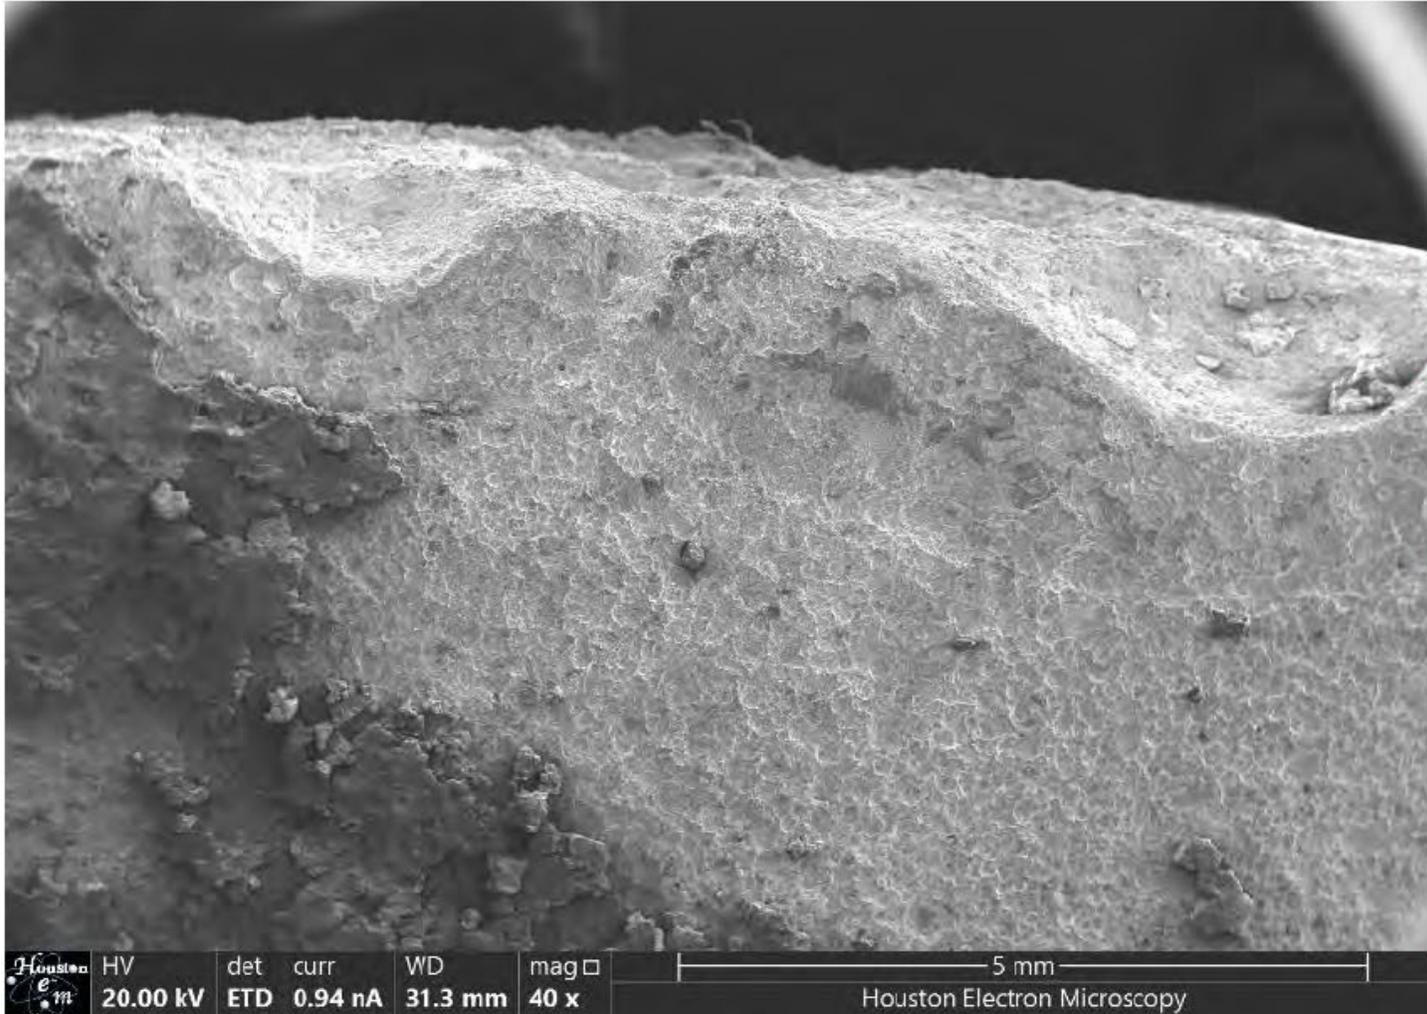
Crack initiation

(Crack-like pit)

Surface Pit

Initial Crack Surface

← Transition in Fracture Morphology

Fracture Surface
