Incidents and Near misses

Aker BP & Equinor – 2023-2024

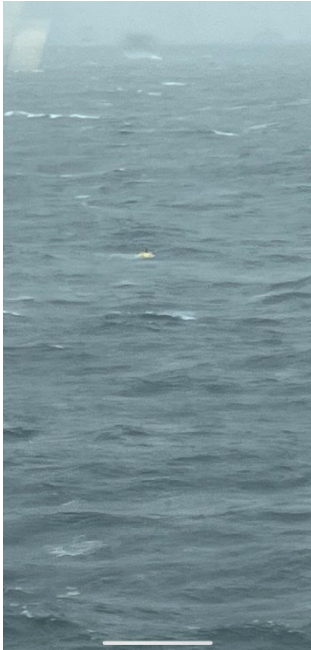
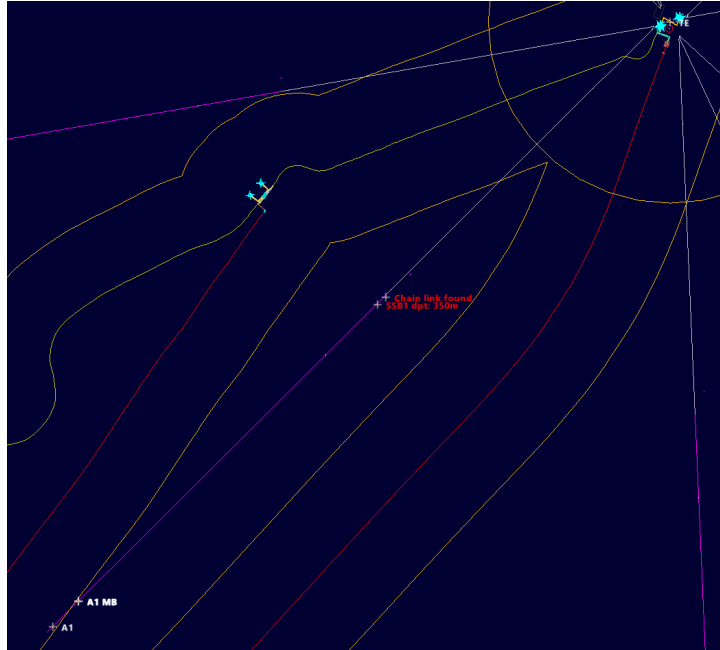
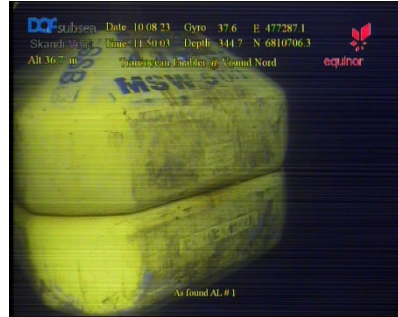
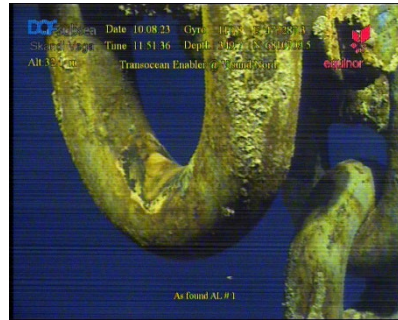
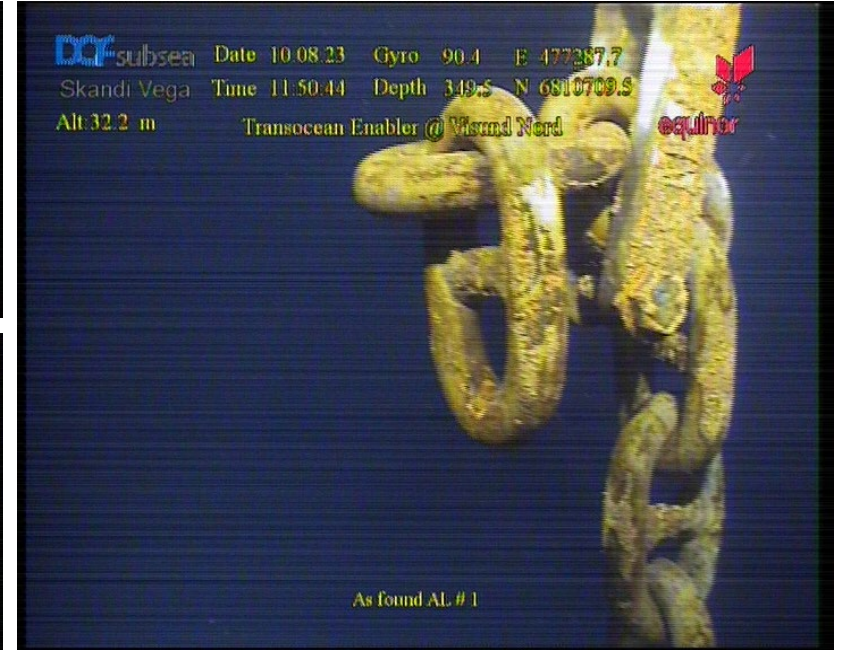
Chain Breakage during pre lay – SC8 @ FGD

- During pre lay at FGD an 84mm R5 chain segment broke. Breakage happened in the crown. Chain was from Ramnæs Bruk AB.
- 2,5m Hs and 320Te tension. Water depth 120m. Polyester used between wire and chain. ICCP turned off.

- Link 491 broke. Links 481 to 490 and 490 to 501, in addition to 491 was examined. In addition, several segments of the chain was sent to DNV for high mean load test (40-50% MBL 400Te). JIP.

- Investigation shows tensile strength and hardness within DNV-OS-302 (356 HV and 1113 Mpa).
- Material has failed in a brittle manner, characterized by intergranular cracking. Not possible to establish if a pre-existing crack had been present before the main fracture has started to propagate. Final rupture is a dimpled ductile rupture (overload).

- Based on previous examination of this type of material, the findings support hydrogen induced cracking to be the reason for the failure of the link.

Damaged link – recovered and sent to Høvik

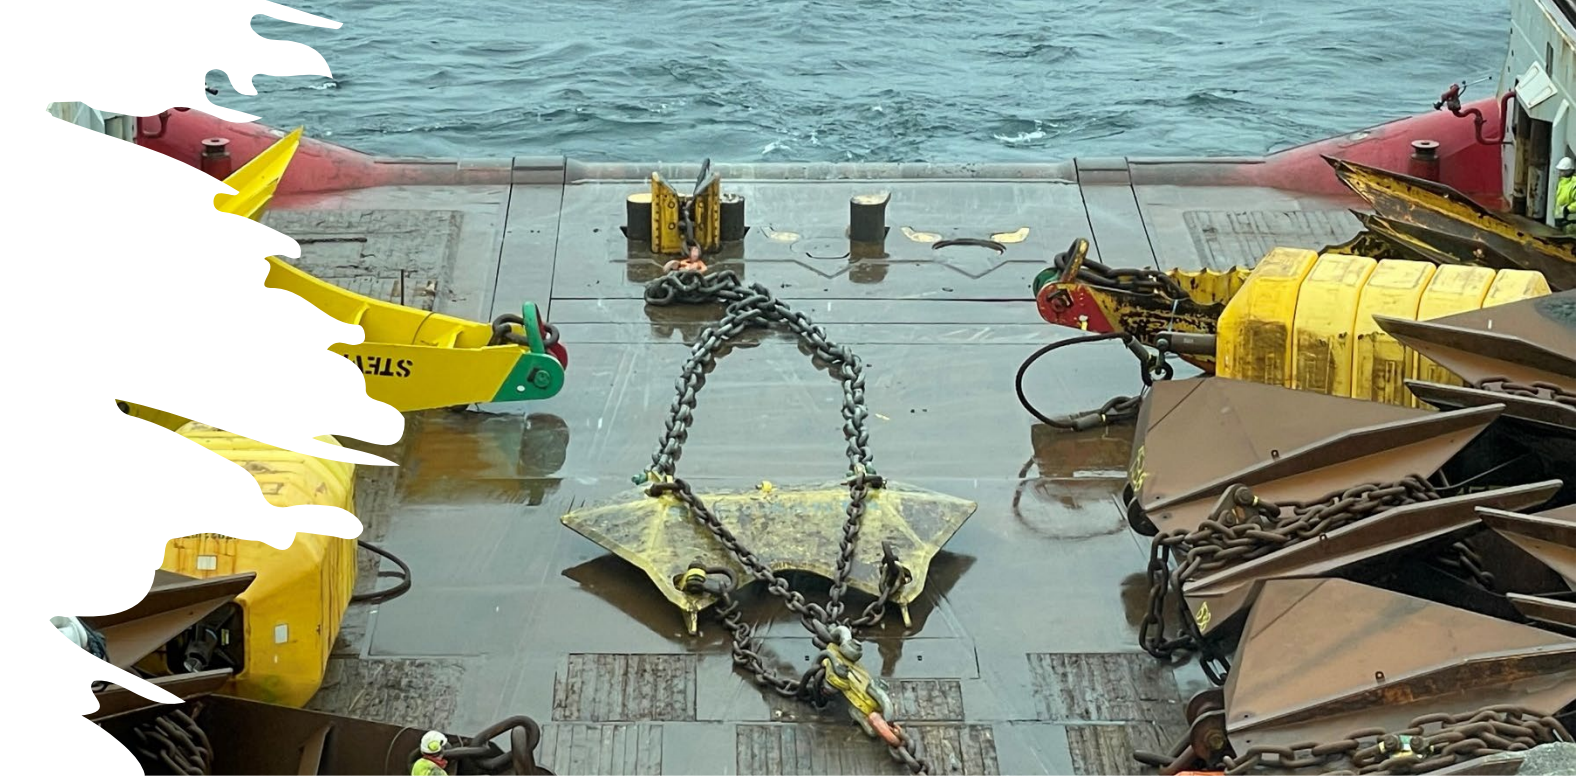
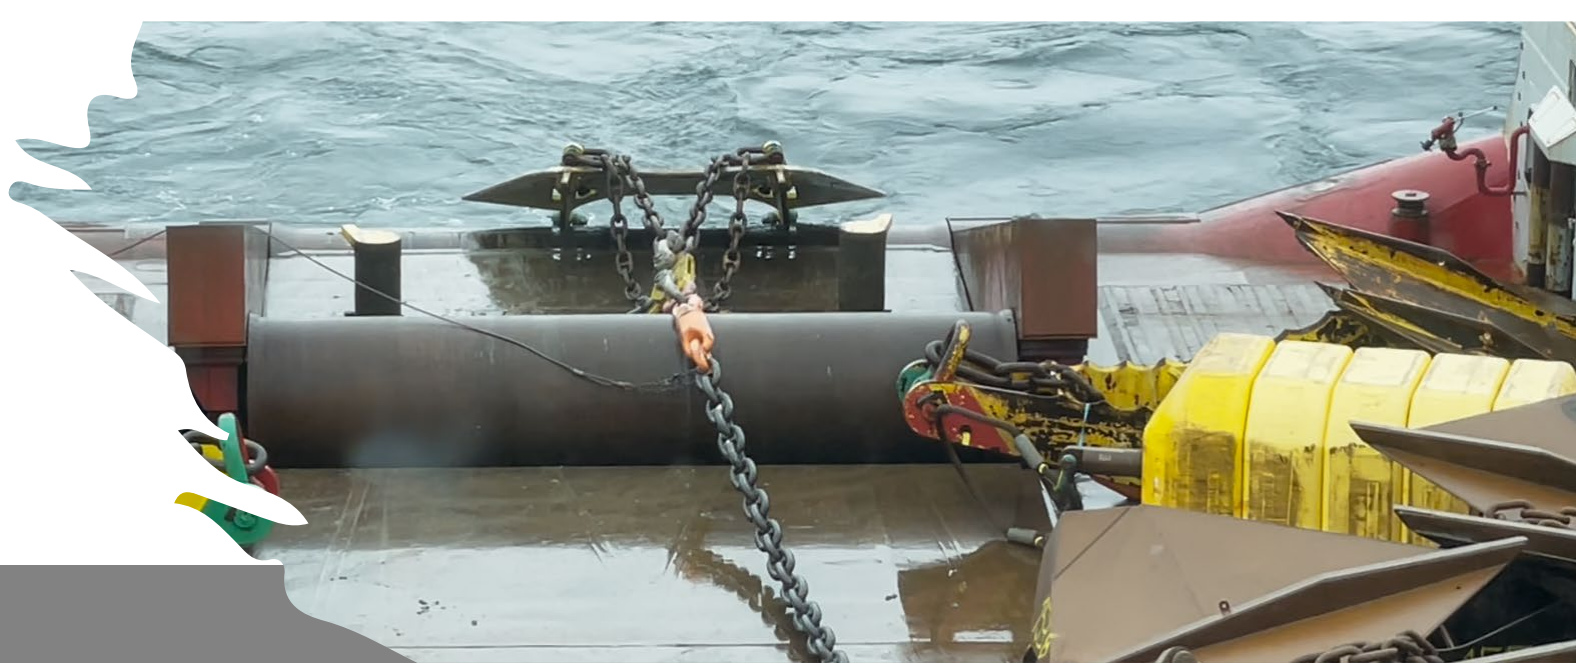
- StevManta – the answer on soft soil ???

- Test went smooth.
- Anchor held 350 tons without problem for 15 min.
- Recovery load was significant lower then the Mk6.
- During recovery of MK 6 anchors on soft soil locations, we can have significant peak loads, the Manta came out at 150 tonnes after short time. No chain on roller that can take damage.
- However;
- The STEVMANTA recovery needs some additional handling time (disconnecting& picking up pennant wire & reconnect) but recovery speeds will more than compensate for the additional handling.
- •Recovery is also more vertical, requiring less free seabed space, important on areas with a lot of infrastructure
- •Potentially take more anchors on one vessel ?

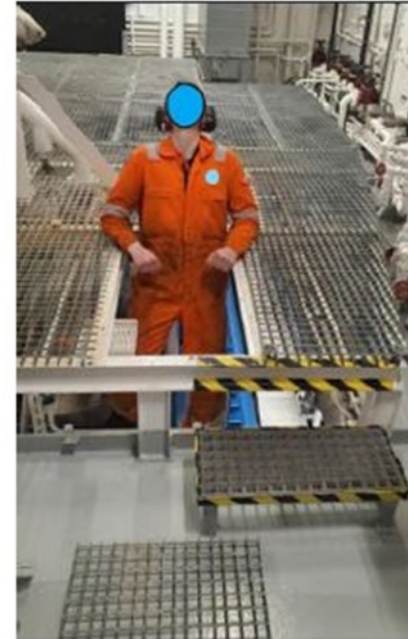
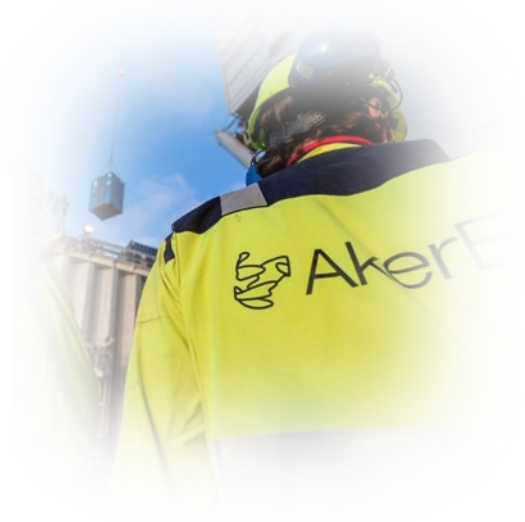
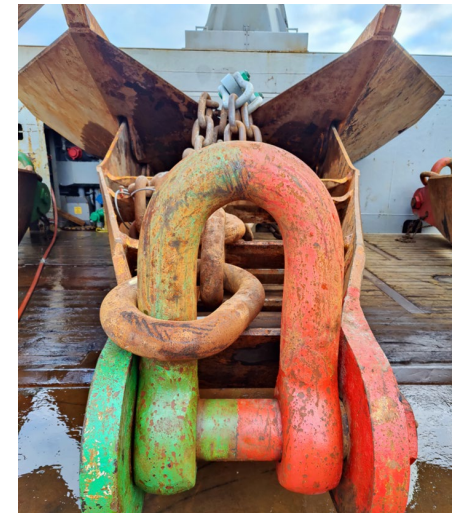
Other incidents we NEED to mention

- Grating – Personal injury – PSV
- Sprained fingers – Special end link
- Twisting of ankles – Two cases last year
- Knee Injury

Focus in everything you do!

Risk picture and stop the job attitude!

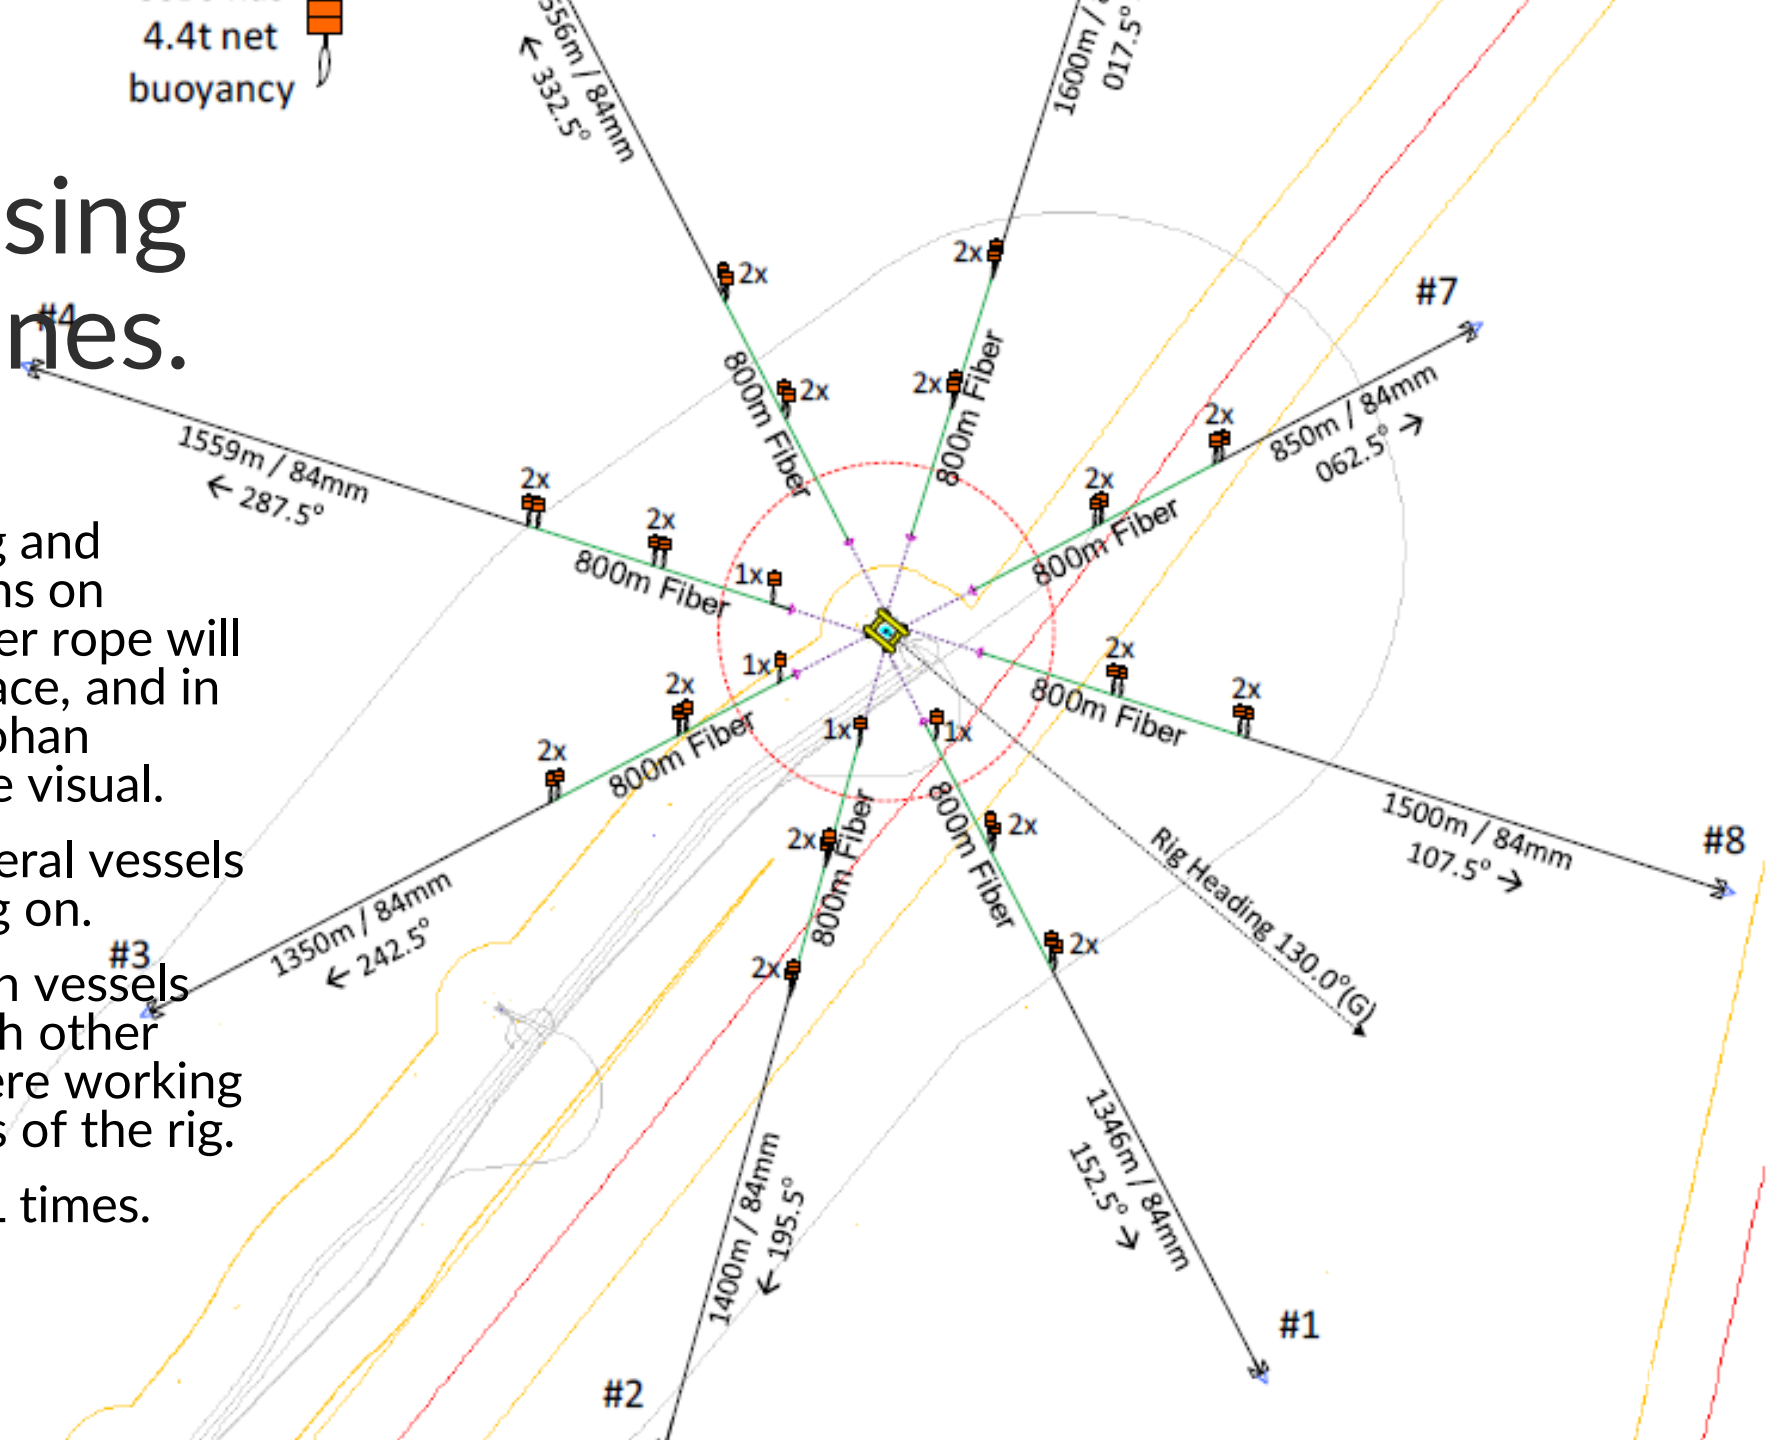
Avoid crossing of anchorlines.

- During unmooring and mooring operations on shallow water, fiber rope will almost reach surface, and in many cases like Johan Sverdrup, it will be visual.
- Rigmoves with several vessels there is a lot going on.
- Had incident when vessels were crossing each other lines, since they were working on several corners of the rig.
- Keep focus at ALL times.

4.4t net buoyancy

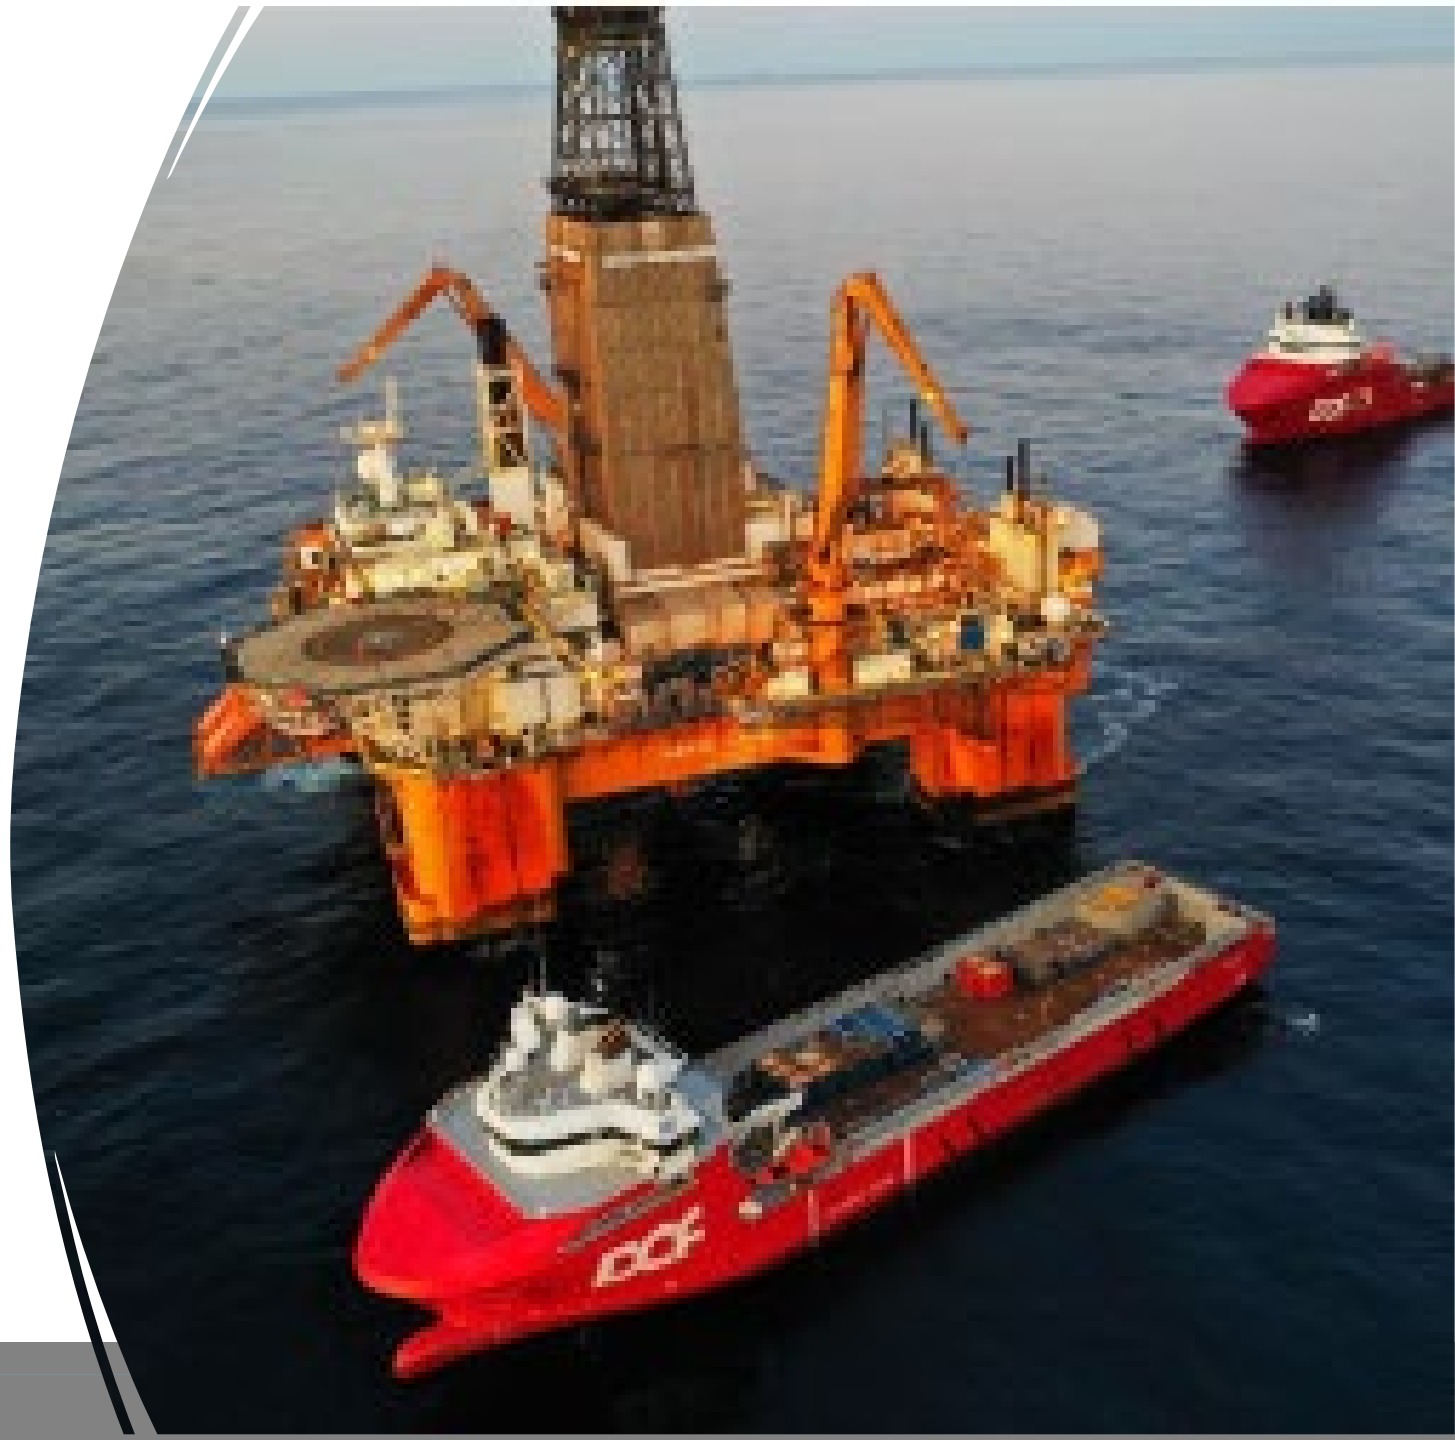
Avoid crossing of anchorlines

- Had incident when vessels were crossing each other's lines, since they were working on several corners of the rig.
- Keep focus at ALL times.

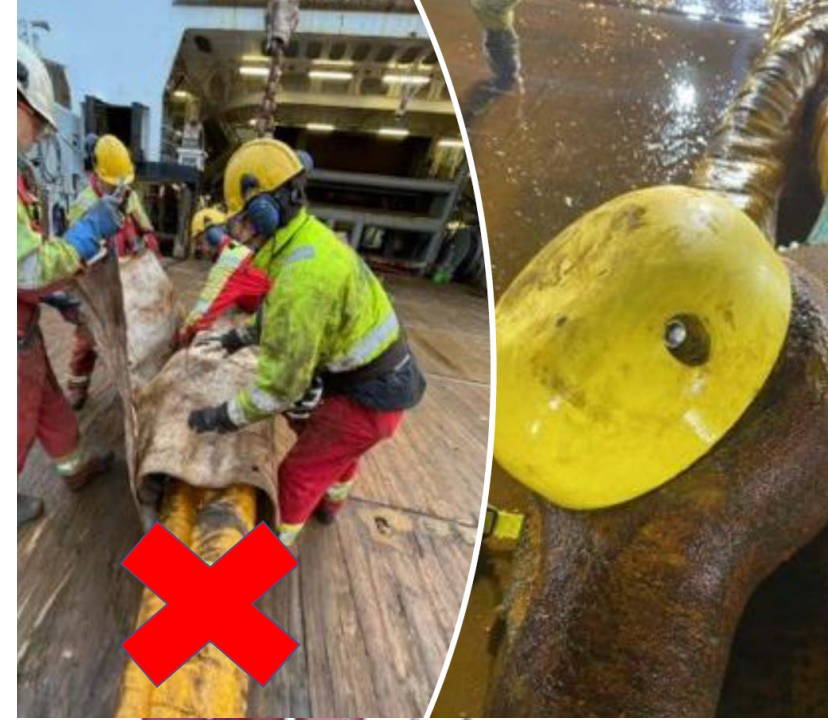
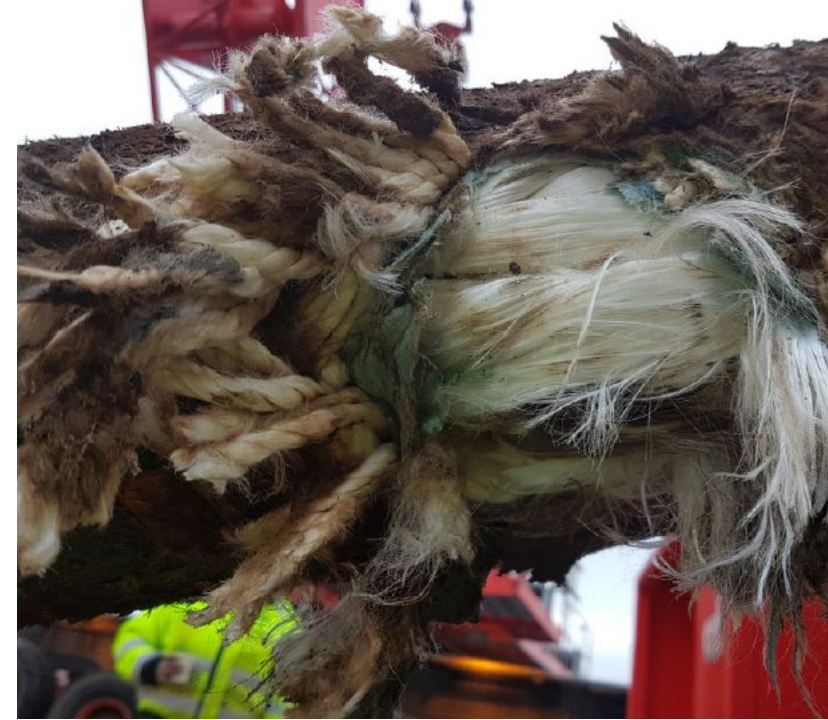
Fiber protection

- Before we had mats around the timble when running it on the winch.
- Could not verify that no sharp edges breach through the fibermats – Also time consuming
- New Poly protection cups is used.
- Quick to install, takes one man and if/when they fall off, we get a visual of this and can stop the operation and hinder fiber damage
